# ESD at the 1-Meter Telescope

DARK ENERGY  
SURVEY

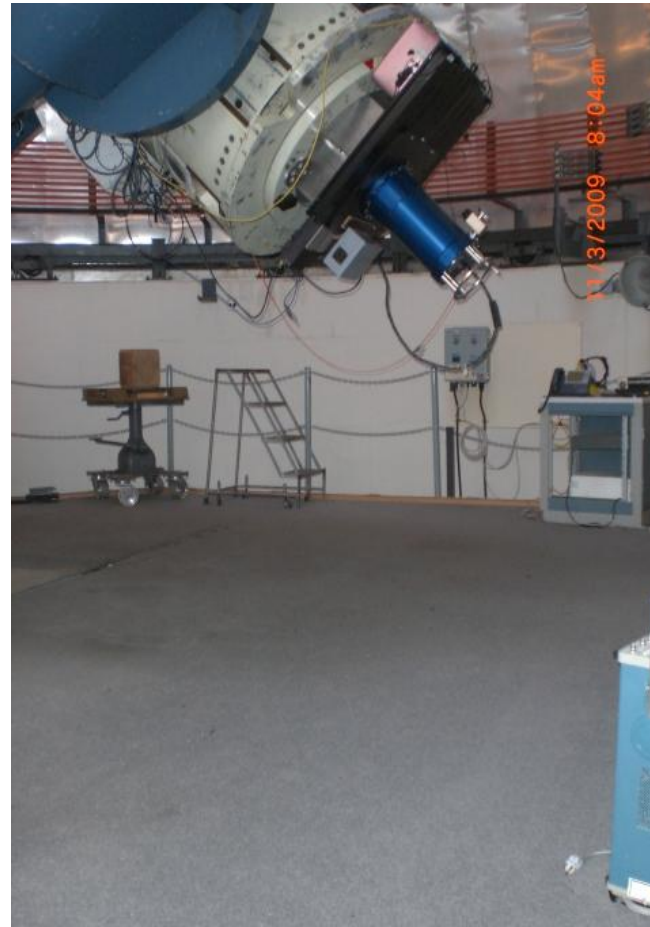
- This ESD shock event illustrated the definite significant ESD hazards that exists and provides fairly conclusive evidence of the probable cause of past CCD failures.

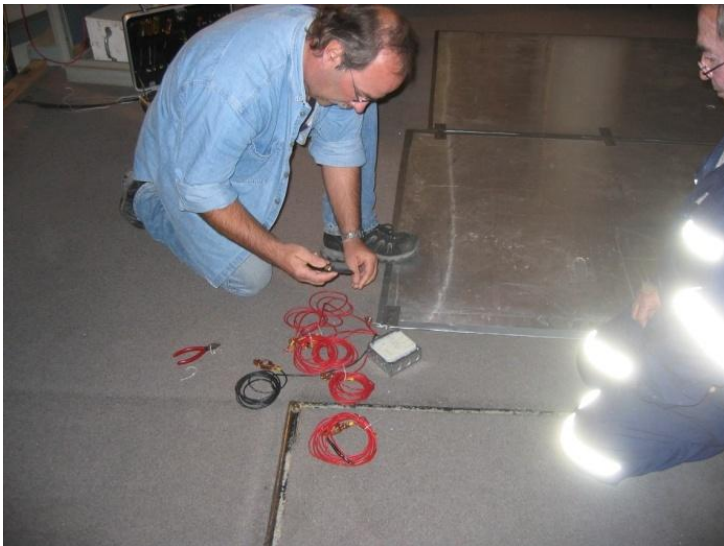
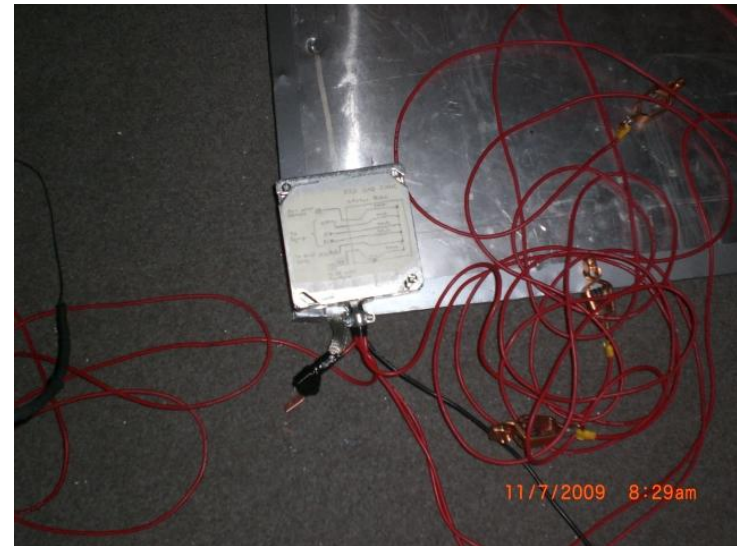
- An improvised ESD safe work surface and grounding straps were installed (with Gale's help) on Wednesday and Thursday prior to the installation of the dewar and electronics crate.

- A draft procedure for mitigation of the ESD hazards during installation of the dewar and crate was included with Tom Diehl's docdb #3790-v3 presentation at the integration meeting on Wednesday afternoon (11-4-2009).
- A trial run of this procedure was done during the dewar and crate installation on Thursday (the 5<sup>th</sup>) afternoon.
- A final draft of the procedures for ESD hazard mitigation is written and included with this docdb presentation.
  - There are four separate ESD procedures with specific steps to take during four types of tasks: 1) installation of the dewar and crate, 2) removal of the dewar and crate, 3) working on or around the dewar while it is installed, 4) recharging the dewar with N<sub>2</sub>.
